**Flood Control Project Maintenance
Levee Inspections**

Fall 2018 Levee Maintenance Deficiency Summary Report

**Flood Control Project Maintenance
Levee Inspections****LMA District Cover Sheet****Fall 2018 Levee Inspection Results****Reclamation District No. 0341 Sherman Island**

Reclamation District No. 0341 Sherman Island

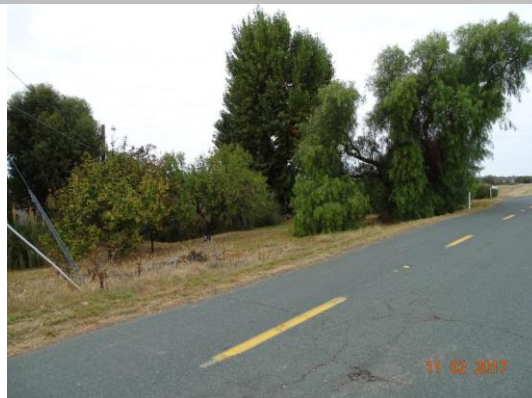
Photo 1 of 1 : FA_2018_RD0341_167_20_20180925_00001.jpg

LM Start	0.76	Rating **	M	Issue No.	20
LM End	0.76	Issue Type +	En	Location *	LS
Category	Earthen Levee			GPS Latitude/Longitude	
				Start	End
Item	Vegetation			38.096477 °	38.096477 °
				-121.686908 °	-121.686908 °
DWR ID	DWR_RD0341_01_f_2018_20				
Comment Code					
V6 : Landscaping					
Inspector Comment					
Landscaping should be reduced and maintained.

Large willow tree and pampas grass partially blocks visibility and access to landside slope and toe. This landscaping should be trimmed/thinned.

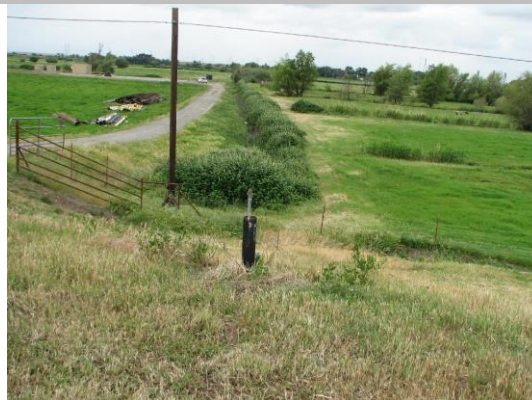
Photo 2 of 3 : UCIP_FA_2018_52255_37663.jpg

FS_ID:52255
DS_ID:24113
EP_NO: 11095
Repair Type: Non-Urgent
Crossing Status: Found
UCIP Comments: 07/06/2016 According to LMA Superintendent, Joel McElroy, this pipe is an irrigation siphon pipe and not a drainage pipe. Primer stem and primer is located on the LS near the berry shrubs. (DWR UCIP - O. Magana)
05/05/2009 Dense vegetation limits the inspector's visibility to identify signs of pipe failure (leaks) along the slope. Recommend removing vegetation along pipe alignment to conduct proper inspection of structure and appurtenances. (DWR UCIP - O. Magana)
FIELD_STRUCT_DESC: 18-inch steel irrigation siphon pipe sleeved through 24-inch pipe through the levee, 4 feet below the crown. Primer stem and primer located on the landside (LS). Pipe exposed on the waterside (WS) slope. (18-inch pipe authorized under Automatic Board Order (ABO) issued as Permit No. 11095, 1975 - A. M. Cabral).
[Additional Reference(s): DWR Levee Log, 1992. LMA encroachment station (STA) reference based on Map of Evacuation Route, Reclamation District 341 Sherman Island by Wagner Bonsignore Consulting Civil Engineers, A Corporation dated July 2012, STA 118+00]

View of LS--visible standup pipe with primer stem is located on the LS slope.

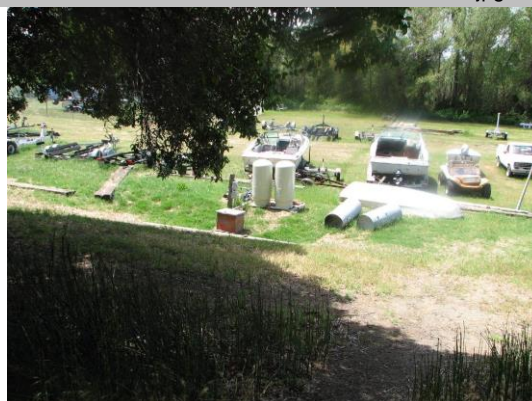
Photo 3 of 3 : UCIP_FA_2018_52258_37703.jpg

Comment Code						
Inspector Comment						
FS_ID:52258 DS_ID:24116 EP_NO: 11103 Repair Type: Non-Urgent Crossing Status: Found UCIP Comments: 05/05/2009 Unable to determine if crossing is the same as permitted under permit no. 11103. Need to contact owner and determine status of crossing under permit no. 11103. Believe steel conduit is exposed on landward side. (DWR UCIP - O. Magana) FIELD_STRUCT_DESC: 1.5-inch iron water pipe and 3.5-inch electrical steel conduit through the levee, both 3 feet below the crown. Pressure system and service pole located on the landside (LS) slope. Fishing resort located on the waterside (WS). (1.5-inch pipe authorized under Automatic Board Order (ABO) issued as Permit No. 11103, 1975 - Western Water Ways, Inc.; 3.5-inch not listed in Permit No. 11103) [Additional Reference(s): DWR Levee Log, 1992. LMA encroachment station (STA) reference based on Map of Evacuation Route, Reclamation District 341 Sherman Island by Wagner Bonsignore Consulting Civil Engineers, A Corporation dated July 2012, STA 71+00] FS Date: 5/5/2009

View of LS.

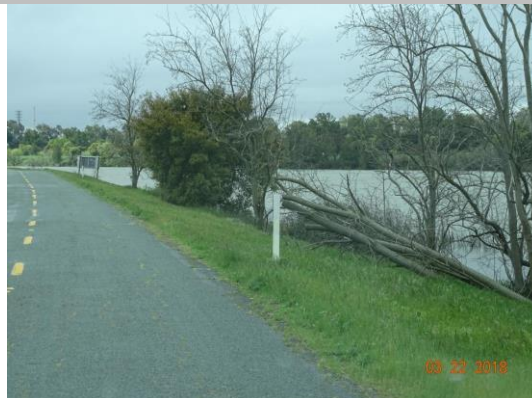
Photo 1 of 1 : FA_2018_RD0341_167_21_20180925_00002.jpg

LM Start	2.19	Rating **	M	Issue No.	21
LM End	2.19	Issue Type +	Ma	Location *	WS
Category	Earthen Levee			GPS Latitude/Longitude	
				Start	End
Item	Encroachments			38.113144 °	38.113144 °
				-121.687601 °	-121.687601 °
DWR ID	DWR_RD0341_01_s_2018_21				
Comment Code					
TR : Tree or limb					
Inspector Comment					
Remove fallen tree on waterside slope.

Fallen tree on waterside slope should be removed.

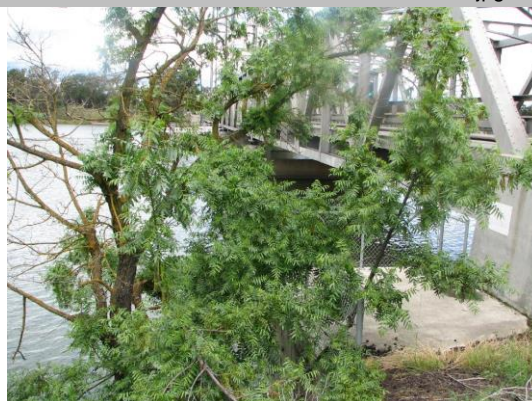
Photo 1 of 3 : UCIP_FA_2018_52267_37780.jpg

View of WS.

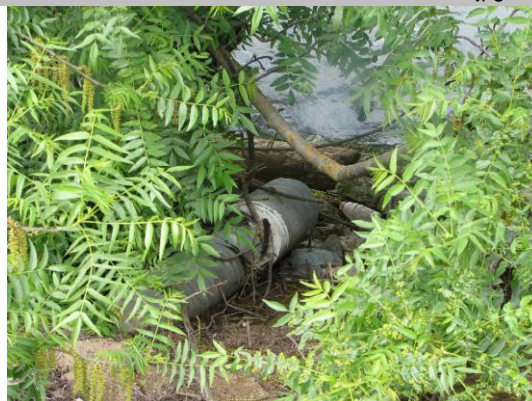
Photo 2 of 3 : UCIP_FA_2018_52267_37783.jpg

Pipe visible on the WS.

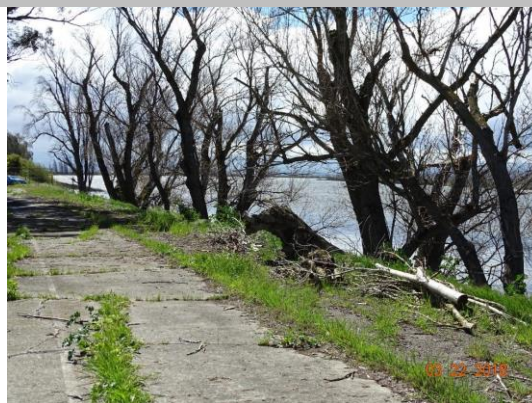
Photo 1 of 1 : FA_2018_RD0341_168_46_20180925_00008.jpg

LM Start	3.88	Rating **	M	Issue No.	46
LM End	3.88	Issue Type +	Ma	Location *	WS
Category	Earthen Levee			GPS Latitude/Longitude	
				Start	End
Item	Encroachments			38.099054 °	38.099054 °
				-121.706368 °	-121.706368 °
DWR ID	DWR_RD0341_02_s_2018_46				
Comment Code					
TR : Tree or limb					
Inspector Comment					
Remove tree and limbs from waterside shoulder.

Tree trunk and limbs should be removed from waterside shoulder.

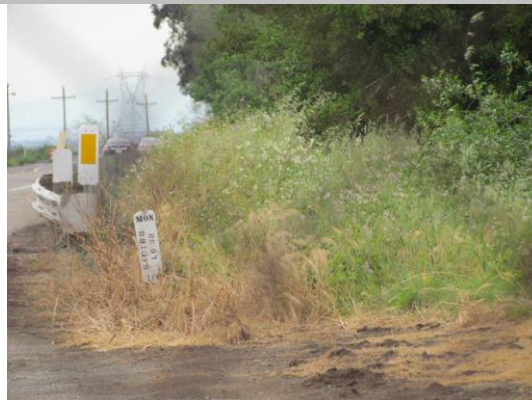
Photo 2 of 2 : FA_2018_RD0341_168_41_20180925_00002.jpg

LM Start	3.94	Rating **	U	Issue No.	41 (cont)	
LM End	6.14	Issue Type +	Ma	Location *	WS	
Category	Earthen Levee			GPS Latitude/Longitude		
				Start		End
Item	Vegetation			38.098158 °		38.080223 °
				-121.706320 °		-121.730312 °
DWR ID	DWR_RD0341_02_s_2017_41					
Comment Code						
V2 : Remove the wild growth other than native grasses from the levee slopes.						
Inspector Comment						
Remove the unwanted vegetation from the waterside shoulder and slope.

Looking downstream from levee mile 3.94 at tall unwanted weeds and other vegetation on the waterside shoulder and slope.

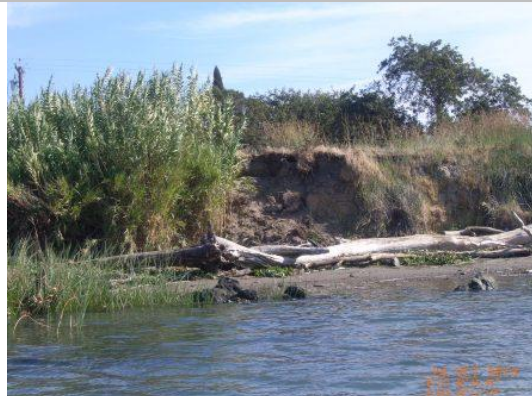
Photo 1 of 1 : FA_2018_RD0341_168_35_20181023_00085.jpg

LM Start	4.47	Rating **	U	Issue No.	35
LM End	4.70	Issue Type +	Ma	Location *	WS
Category	Supplemental			GPS Latitude/Longitude	
				Start	End
Item	2017 USACE Erosion Survey, DRAFT			38.090620 °	38.087425 °
				-121.706684 °	-121.707639 °
DWR ID	DWR_RD0341_02_f_2018_35				
Comment Code					
Inspector Comment					
2017 Site ID: SAC 8.0 L					
Status: Critical					
2017 Field Notes: Site extended downstream					
Site History: 1999 - New small slump in eroded bank. 2005 - Reach extended because of vertical bank along the roadway upstream. 2011 - More slumping since last year. 2012 - Site upgraded to critical. Very steep slope which may be effecting the highway on top of the levee. 2015 - New erosion towards the downstream end of site.

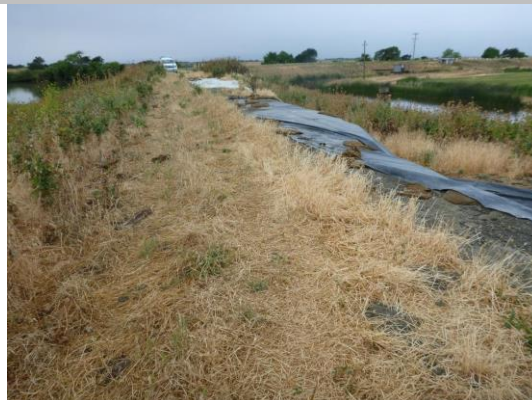
Photo 1 of 3 : FA_2018_RD0341_168_42_20180925_00003.jpg

LM Start	4.75	Rating **	A/W	Issue No.	42
LM End	4.79	Issue Type +	Ma	Location *	
Category	Supplemental			GPS Latitude/Longitude	
				Start	End
Item	2017 Storm Damage			38.086641 °	38.086119 °
				-121.707545 °	-121.707912 °
DWR ID	DWR_RD0341_02_f_2017_42				
Comment Code					
Inspector Comment					
Levee Evaluation Comments					
Description:					
Site ID No:65					
Site Designation:DWR_RD0341_02_s_2012_8					
Repair Type: Erosion					
Rating:Area of Concern					
Field Date:6/8/2017					
Notes: hwy 160 forms levee crown road, erosion has encroached into paved crown, crown 38' wide. This site is currently under contract for repair under FSRP.

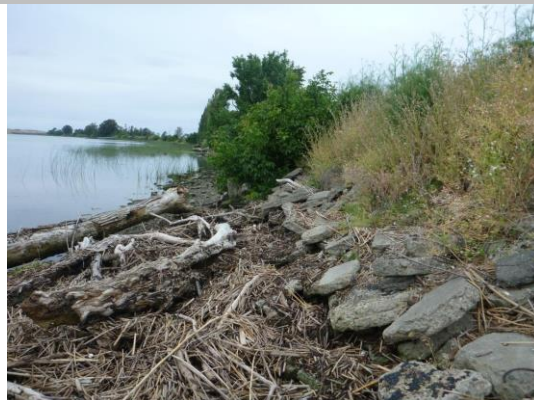
Photo 2 of 3 : FA_2018_RD0341_168_42_20180925_00004.jpg

LM Start	4.75	Rating **	A/W	Issue No.	42 (cont)	
LM End	4.79	Issue Type +	Ma	Location *		
Category	Supplemental			GPS Latitude/Longitude		
				Start		End
Item	2017 Storm Damage			38.086641 °		38.086119 °
				-121.707545 °		-121.707912 °
DWR ID	DWR_RD0341_02_f_2017_42					
Comment Code						
Inspector Comment						
Levee Evaluation Comments						
Description:						
Site ID No:65						
Site Designation:DWR_RD0341_02_s_2012_8						
Repair Type: Erosion						
Rating:Area of Concern						
Field Date:6/8/2017						
Notes: hwy 160 forms levee crown road, erosion has encroached into paved crown, crown 38' wide. This site is currently under contract for repair under FSRP.

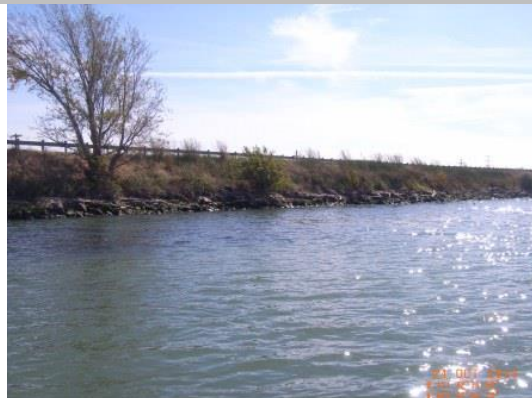
Photo 1 of 1 : FA_2018_RD0341_168_34_20181023_00084.jpg

LM Start	4.76	Rating **	A/W	Issue No.	34
LM End	5.01	Issue Type +	Ma	Location *	WS
Category	Supplemental			GPS Latitude/Longitude	
				Start	End
Item	2017 USACE Erosion Survey, DRAFT			38.086603 °	38.083954 °
				-121.707786 °	-121.710589 °
DWR ID	DWR_RD0341_02_f_2018_34				
Comment Code					
Inspector Comment					
2017 Site ID: SAC 7.9 L					
Status: Critical					
2017 Field Notes: Road base exposed in multiple locations. New tree popout observed.					
Site History: 2011 - Large slump section. 2012 - Site extended downstream, upgraded to critical, severe windwave. Slope is very steep and may be effecting the highway on top of the levee.

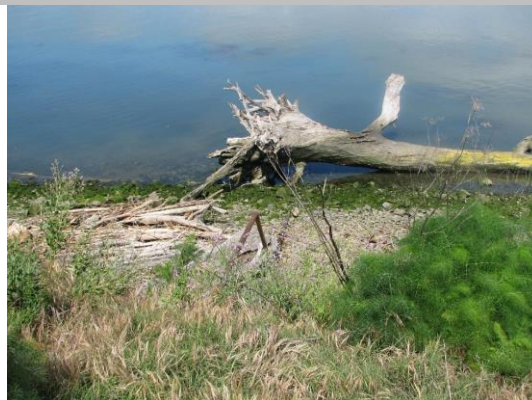
Photo 1 of 2 : UCIP_FA_2018_22186_37787.jpg

Comment Code						
Inspector Comment						
FS_ID:22186 DS_ID:24123 EP_NO: 4855 Repair Type: Non-Urgent Crossing Status: Found UCIP Comments: Dense vegetation limits the inspector's visibility to identify signs of pipe failure (leaks) along the slope. Recommend removing vegetation along pipe alignment to conduct proper inspection of structure and appurtenances. FIELD_STRUCT_DESC: 2-inch steel irrigation pipe through the levee, 3.0 feet below the crown. Valve and pump on landside (LS). Rock revetment placed on waterside (WS) slope. (2-inch pipe authorized under Permit No. 4855, 1965 - A. Cabral) [Additional Reference(s): DWR Levee Log, 1992. LMA encroachment station (STA) reference based on Map of Evacuation Route, Reclamation District 341 Sherman Island by Wagner Bonsignore Consulting Civil Engineers, A Corporation dated July 2012, STA 948+00] FS Date: 5/6/2009

View of crossing on waterward side--dense vegetation on slopes.

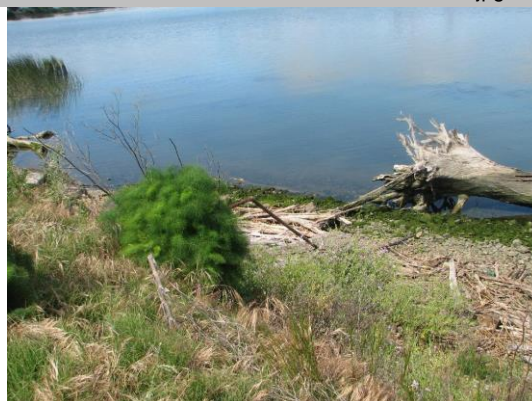
Photo 2 of 2 : UCIP_FA_2018_22186_37786.jpg

Comment Code						
Inspector Comment						
FS_ID:22186 DS_ID:24123 EP_NO: 4855 Repair Type: Non-Urgent Crossing Status: Found UCIP Comments: Dense vegetation limits the inspector's visibility to identify signs of pipe failure (leaks) along the slope. Recommend removing vegetation along pipe alignment to conduct proper inspection of structure and appurtenances. FIELD_STRUCT_DESC: 2-inch steel irrigation pipe through the levee, 3.0 feet below the crown. Valve and pump on landside (LS). Rock revetment placed on waterside (WS) slope. (2-inch pipe authorized under Permit No. 4855, 1965 - A. Cabral) [Additional Reference(s): DWR Levee Log, 1992. LMA encroachment station (STA) reference based on Map of Evacuation Route, Reclamation District 341 Sherman Island by Wagner Bonsignore Consulting Civil Engineers, A Corporation dated July 2012, STA 948+00] FS Date: 5/6/2009

View of waterward toe.

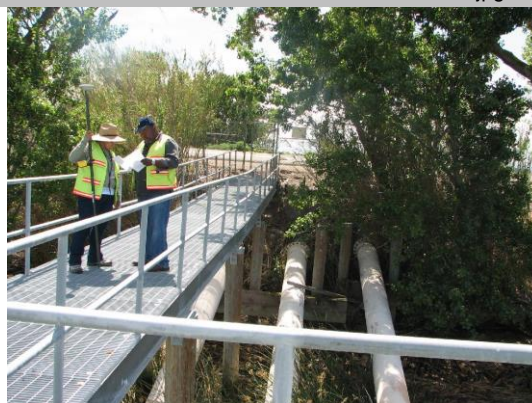
Photo 1 of 3 : UCIP_FA_2018_22253_37885.jpg

FS_ID:22253
DS_ID:24195
EP_NO: 15175
Repair Type: Non-Urgent
Crossing Status: Found
UCIP Comments: Dense vegetation limits the inspector's visibility to identify signs of pipe failure (leaks) along the slope. Recommend removing vegetation along pipe alignment to conduct proper inspection of structure and appurtenances.
FIELD_STRUCT_DESC: [Horseshoe Intake] 1 of 4: 24-inch steel irrigation pipe in 30-inch steel casings through the levee, 6.6 feet below the crown. Annular gap grouted between pipes. Siphon breakers located on the waterside (WS) shoulder, with concrete risers on both ends. Screened inlet manifold (36-inch) with backwash system on pile structure in stream. Surrounded by fence with entry gate. Irrigation pond located on the landside (LS) toe. (three 24-inch pipe authorized under Permit No. 15175, 1993 -Reclamation District 341 [RD0341]; replacement of 210 feet of existing 24-inch pipes, join two pipes at an inlet with a 36-inch screened manifold intake, add bypass valves on both lines, install an access platform, and pressurized backwash system to clean fish screens authorized under Permit No. 16737, 2000 - Department of Water Resources [DWR]) [Additional Reference(s): LMA encroachment station (STA) reference based on Map of Evacuation Route, Reclamation District 341 Sherman Island by Wagner Bonsignore Consulting Civil Engineers, A Corporation dated July 2012, STA 934+00]

Pipes, walkway, fence, and support piles located on waterward side.

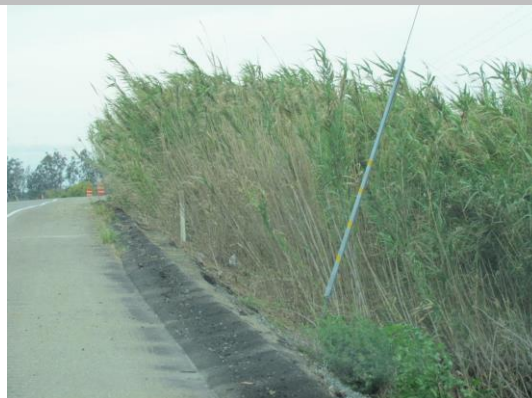
Photo 1 of 1 : FA_2018_RD0341_168_49_20180925_00010.jpg

LM Start	6.03	Rating **	U	Issue No.	49
LM End	6.10	Issue Type +	Ma	Location *	LS
Category	Earthen Levee			GPS Latitude/Longitude	
				Start	End
Item	Vegetation			38.080143 °	38.080125 °
				-121.728332 °	-121.729662 °
DWR ID	DWR_RD0341_02_f_2016_49				
Comment Code					
V2 : Remove the wild growth other than native grasses from the levee slopes.					
Inspector Comment					
Remove the bamboo from the landside levee slope.

RD 341 Landside slope from levee mile 6.03-6.10 tall unwanted growth of Arundo present on the levee section.

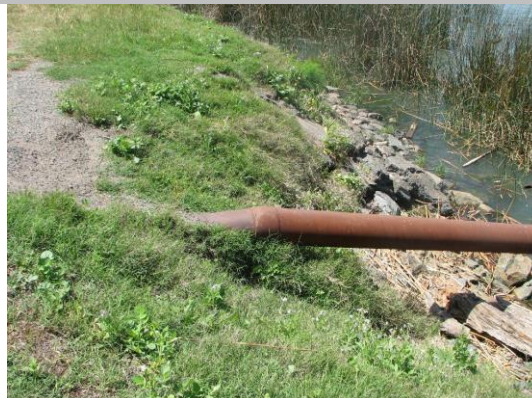
Photo 1 of 3 : UCIP_FA_2018_22261_37949.jpg

Side view of pipe on waterward side.

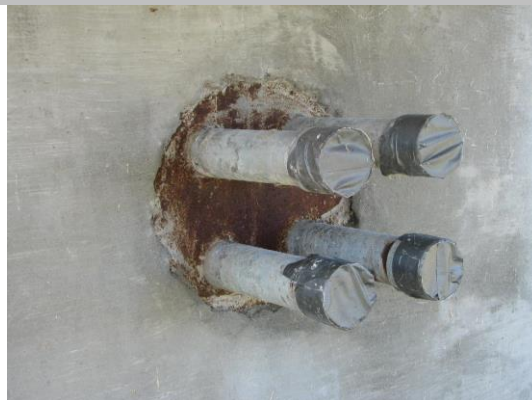
Photo 2 of 3 : UCIP_FA_2018_22303_38061.jpg

Conduits exposed on waterward side.

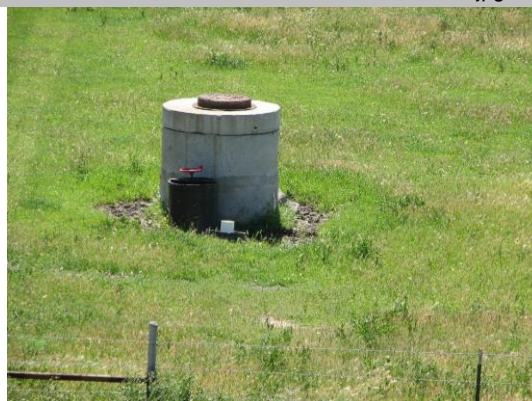
Photo 1 of 3 : UCIP_FA_2018_22309_38075.jpg

Concrete stand pipe and gate valve located on landward side.

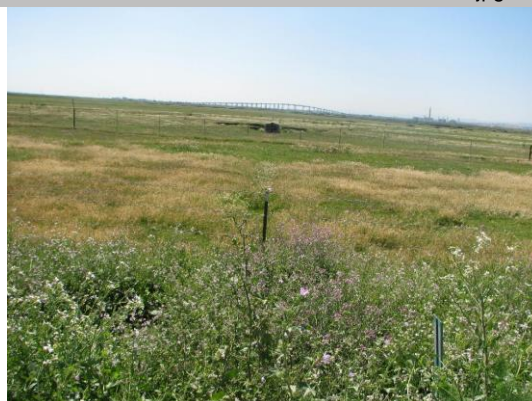
Photo 3 of 3 : UCIP_FA_2018_22324_38094.jpg

Comment Code						
Inspector Comment						
FS_ID:22324 DS_ID:24133 EP_NO: 11114 Repair Type: Non-Urgent Crossing Status: Found UCIP Comments: 7/6/2016 Meet with Joel McElroy, District Representative, at site. DWR Bay Delta Division owns pipe. Need to contact owner to determine status of pipe crossing. (DWR UCIP - O. Magana) 05/06/2009 Dense vegetation limits the inspector's visibility to identify signs of pipe failure (leaks) along the slope. Recommend removing vegetation along pipe alignment to conduct proper inspection of structure and appurtenances. (DWR UCIP - O. Magana) FIELD_STRUCT_DESC: 14-inch steel pipe of unknown purpose through the levee, 4.0 feet below the levee crown. Concrete standpipe with slide gate located on the landside (LS). Rock revetment on the waterside (WS) slope. (14-inch pipe retained under Automatic Board Order (ABO) issued as Permit No. 11114, 1975 - E. J. Trigueiro) [Additional Reference(s): DWR Levee Log, 1992. LMA encroachment station (STA) reference based on Map of Evacuation Route, Reclamation District 341 Sherman Island by Wagner Bonsignore Consulting Civil Engineers, A Corporation dated July 2012, STA 720+00] FS Date: 5/6/2009

Overview of landward side.
